Manhole Inspection Summary

Manhole # S35QQ1021MH

Insp Date: **3/20/07 1:32 PM**

Location Address: **340 WINSTON AVE**

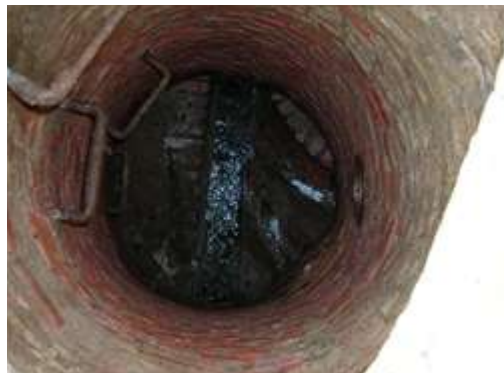
Top View

Corroded steps. Bench debris.

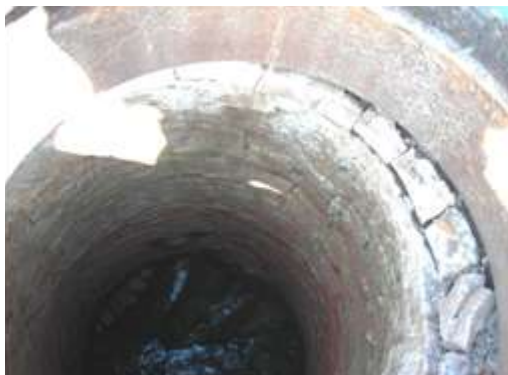
Defect

Frame leaks. Frame offset. Adjustment deterioration and infiltration - other side.

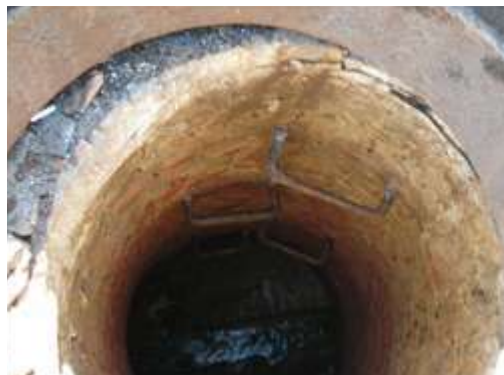
Defect

Frame leaks. Frame offset. Adjustment deterioration and infiltration.

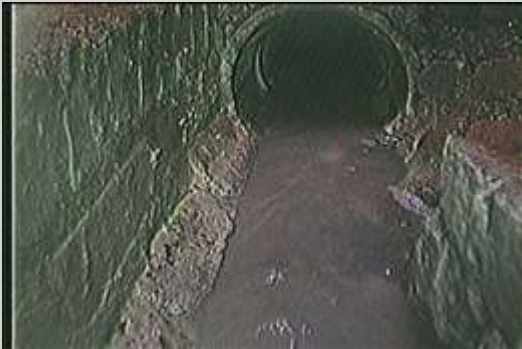
10 in. Circular Gravity Sewer Pipe Out @ 12 O'Clock

Infiltration: **None** Pipe Seal Cond: **Cracked**

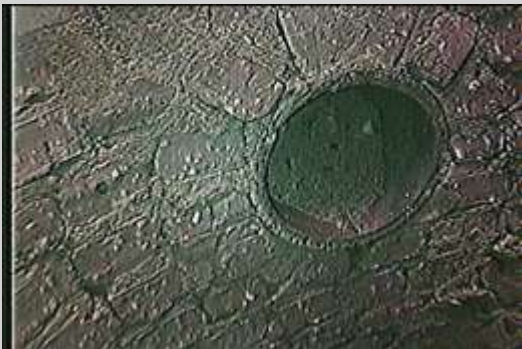
8 in. Circular Gravity Sewer Pipe In @ 3 O'Clock

Plugged.

Deposits: ☐ None ☐ Mud ☐ Sludge ☒ **Debris** ☐ Grease

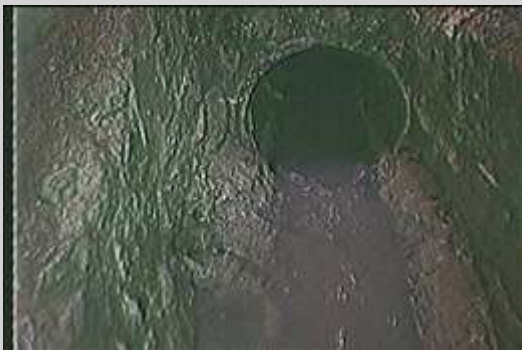
Pipe In @ 6 O'Clock

Infiltration: **None** Pipe Seal Cond: **Cracked**
